## Marine Corps Base, Camp Lejeune Proposed Remedial Action Plan Operable Unit No. 11 (Sites 7 and 80)

January 1997

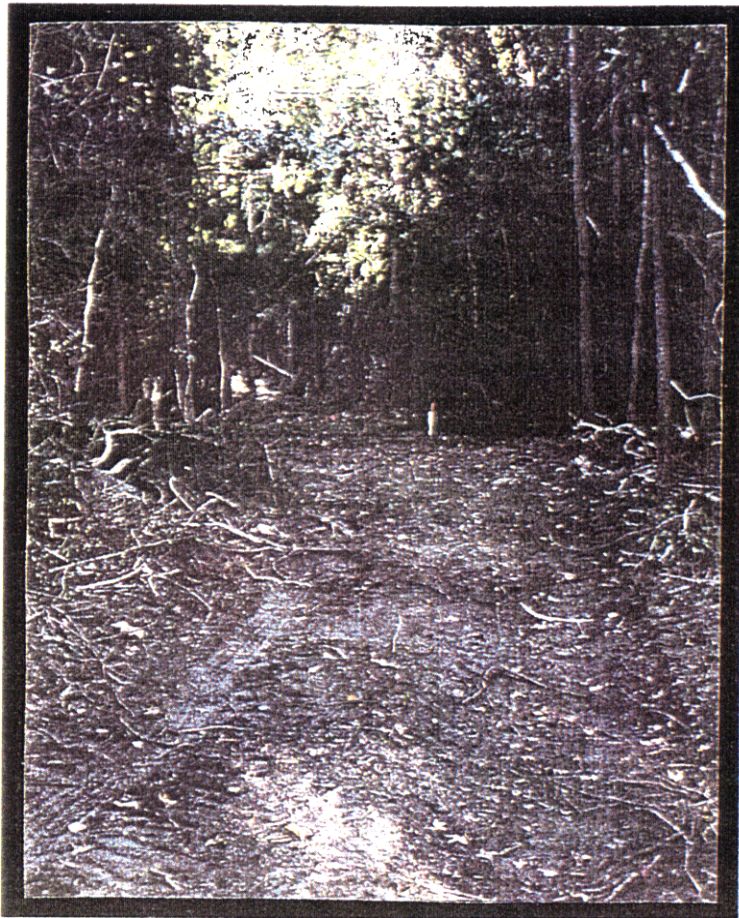
Photograph 1- Site 7

Photograph was taken along the cleared access road in the southwestern portion of Site 7.

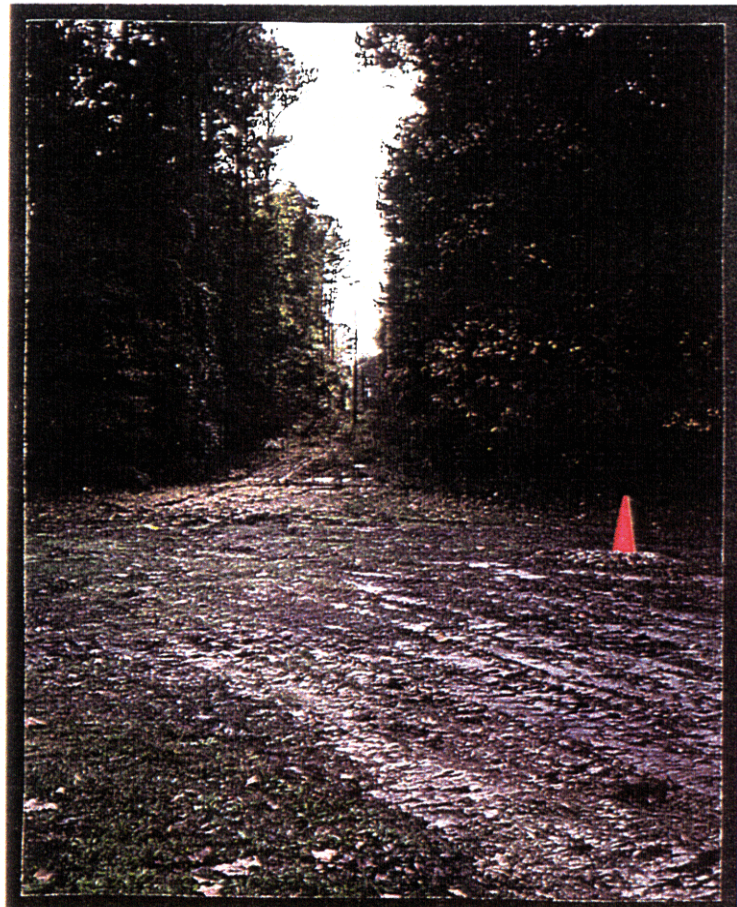
Photograph 2- Site 7

Photograph of an electric service line right-of-way at Site 7

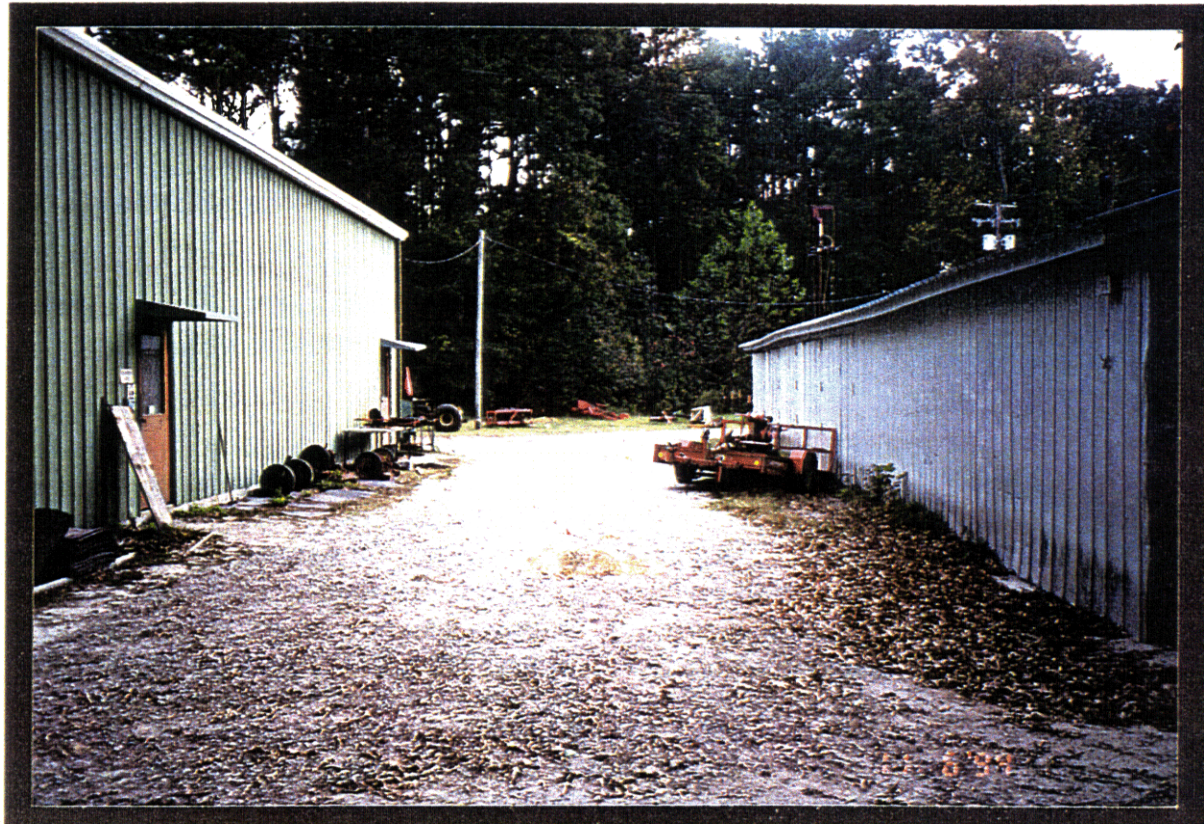
Photograph 1- Site 80

Photograph of machine shop (on left) and maintenance building (on right).

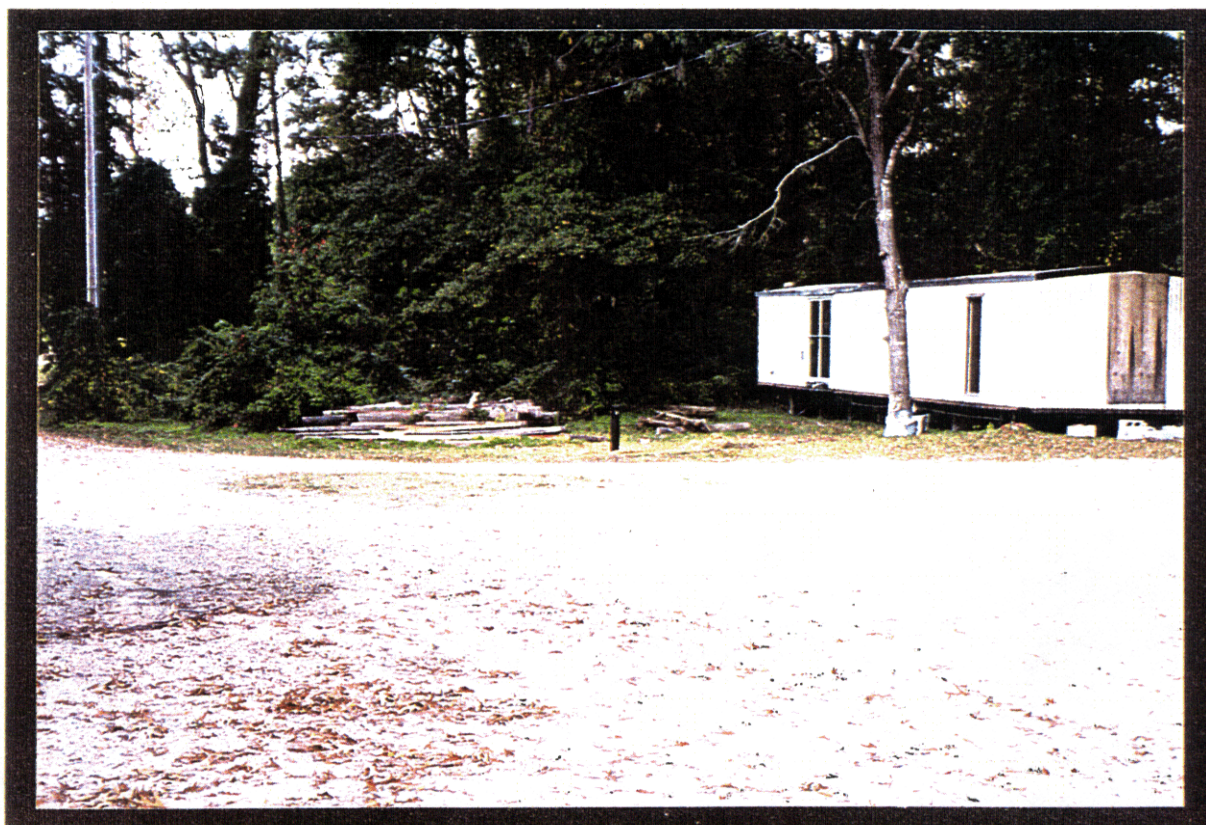
Photograph 2- Site 80

In surface soil, the detected pesticides included dieldrin, 4,4'-DDE, 4,4'-DDD, 4,4'-DDT, alpha-chlordane, and gamma-chlordane. The highest pesticide concentrations were located in the west/northwest portion of the site. PAH (polynuclear aromatic hydrocarbon) constituents and inorganics including arsenic were also detected in the surface soil.

Photograph of the west/northwest area where the time-critical removal action was conducted for pesticide and arsenic contaminated surface soil.

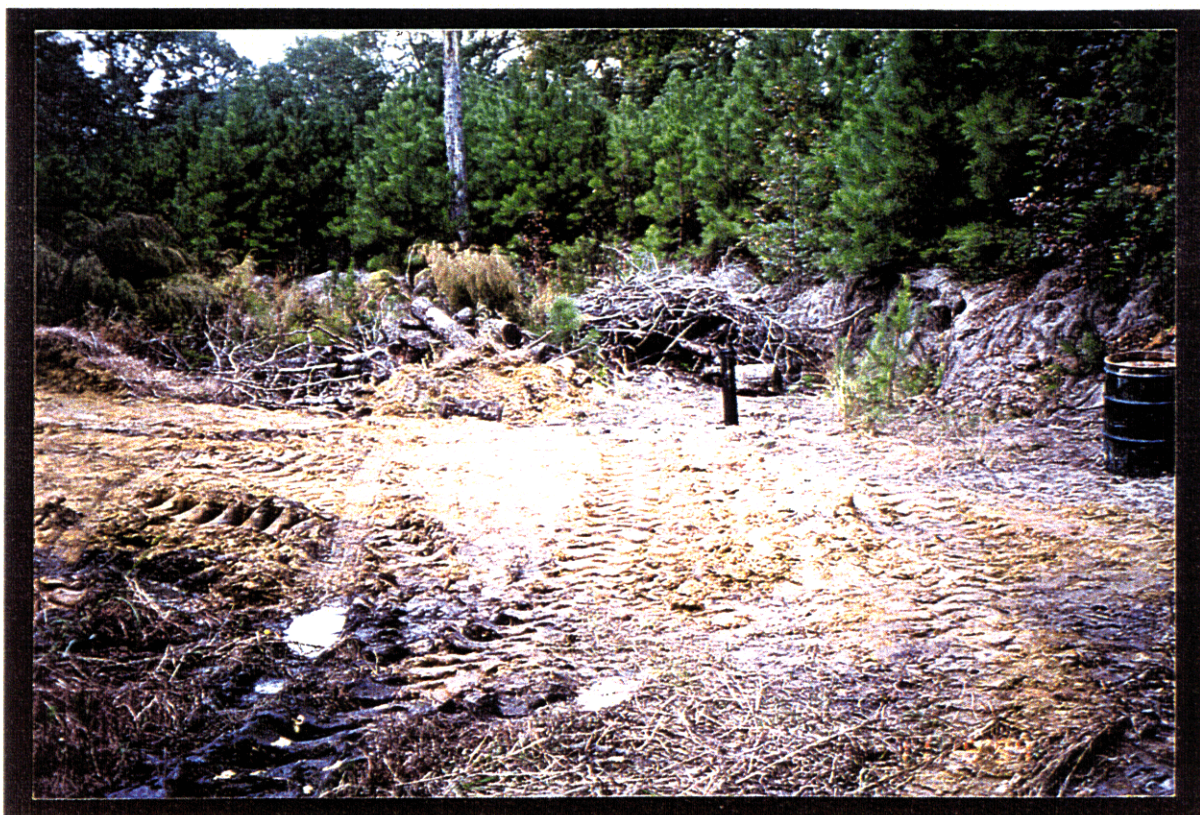
Photograph 3- Site 80

Photograph of the debris pile located in the northern portion of Site 80.
